# STAVLAS HOME INSPECTIONS

## Inspection Report

1205 Cobb Rd  
Pikesville MD 21208

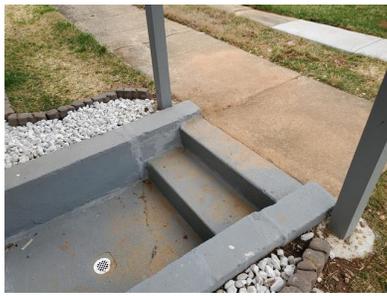
Left Rear Basement Stairwell Retaining Walls (Concrete Block/ Monitor Previous Repairs)

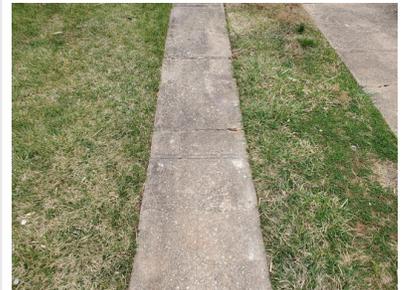
**2.0 Item 3 (Picture)**  
Driveway Cracked (Multiple Locations)

(2) The driveway is cracked. Cracks can permit moisture penetration and can result in cause further damage to the driveway.

RECOMMENDATION: Repair and seal the cracks. Use exterior grade textured caulk, concrete patching compound, or epoxy on concrete driveways. Hire a masonry contractor as needed.

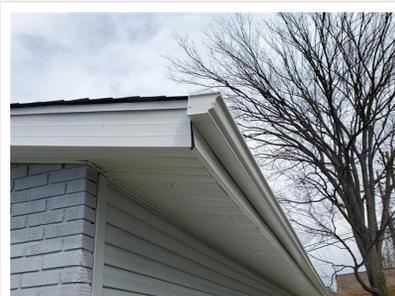
**2.4 Item 1 (Picture)**  
Gap/ Trim (Right Front Fascia Trim)

There is a gap or unsealed opening in the trim. Gaps or unsealed openings can permit moisture to enter, which can result in further damage.

LOCATION: The front right fascia trim.

RECOMMENDATION: Seal any openings. Hire a licensed contractor as needed.

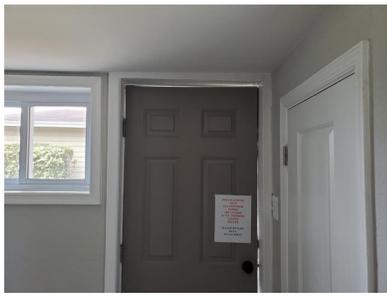
**2.6 Item 1 (Picture)**  
Door Binding (Left Rear Basement Entrance Door)

LOCATION: The left for your basement entrance door and the front entrance door.

RECOMMENDATION: Repair/ trim or replace the doors. Hire a general contractor as necessary.

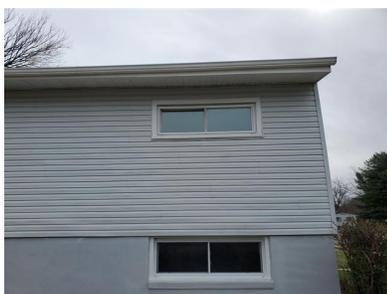
**2.7 Item 1 (Picture)**  
Screen Missing (Left Front/ Second Floor Window)

Window screens are missing or damaged. This affects proper function. Screens provide ventilation while excluding flying insects and other pests. Screens are often removed during winter months or for staging purposes.

RECOMMENDATION: Replace any missing screens.

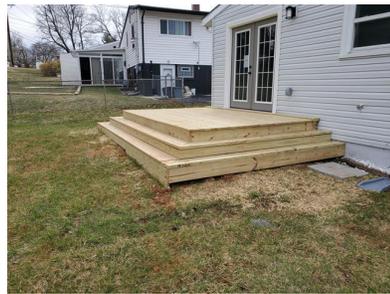
**2.8 Item 1 (Picture)**  
Lower Step Riser Height Excessive (Rear Deck)

LOCATION: The rear deck.

RECOMMENDATION: Hire a licensed contractor to add a landing or lower step so that the riser height does not exceed 7.75 inches. A handrail or handrails will be required if another step is added.

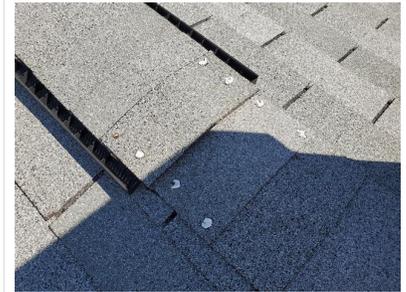
**3.0 Item 3 (Picture)**  
Improperly Sealed/ Exposed Nail Heads (Ridge Vents)

There is an partially driven and exposed nail head, and improperly sealed nail heads on the roof. Unsealed nail heads are prone to rusting and water intrusion.

RECOMMENDATION: Remove or replace the partially driven nail head and seal exposed nail heads with an approved roofing sealant/product. Hire a qualified roofing contractor as needed.

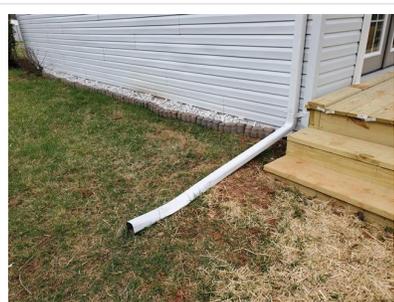
**5.0 Item 1 (Picture)**  
Downspout Extension Crushed  
(Rear Right Downspout)

LOCATION: The right rear downspout.

RECOMMENDATION: Repair or replace the downspout extension.

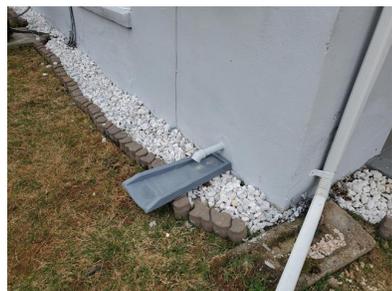
**5.4 Item 1 (Picture)**  
Sump Pump Discharges Too  
Close to Foundation (Rear Left)

LOCATION: The basement sump pump (rear left).

RECOMMENDATION: Extend the pipe to discharge the water at least 6 feet away from the foundation.

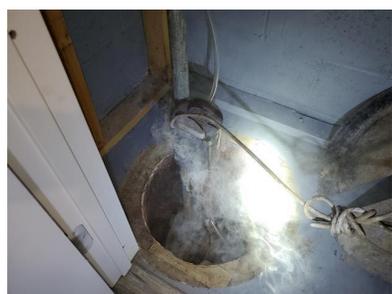
**5.4 Item 2 (Picture)**  
Sump Pump Damaged/  
Inoperative (Basement Rear Left  
Closet/ Sump Pump 1)

❌ (2) The sump pump is damaged/ inoperative. It started to smoke when plugged in. This affects function and is a fire safety concern.

LOCATION: The basement sump pump (rear left closet).

RECOMMENDATION: Replace the damaged pump.

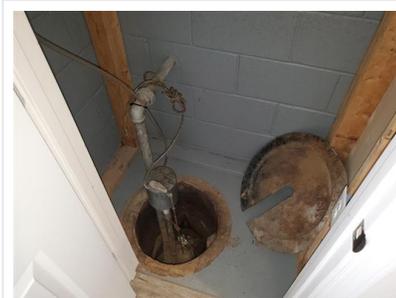
**5.4 Item 3 (Picture)**  
Battery Back-Up System Not Present (Basement Sump Pump)

(3) The sump pumps do not have a battery back-up systems. It is dependent on electrical service. During inclement weather, electrical service outages are more likely and the sump pump will be inoperative. This is the most important time to have sump pump functioning.

LOCATION: Both sump pumps (basement and crawl space).

RECOMMENDATION: Monitor the sumps during and after rain events. If the sumps hold water, consider hiring a contractor to install battery back-up systems.

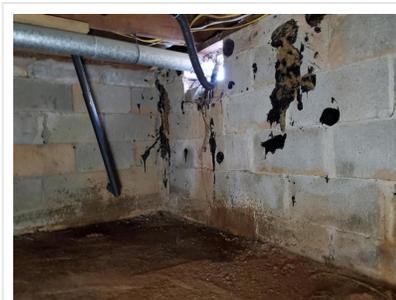
**5.4 Item 5 (Picture)**  
Discharge Line Leaks When Pump Activated (Crawl Space Sump Pump)

(4) The sump pump discharge line leaks into the crawl space when the sump pump is activated. This prevents proper operation and can permit water-related issues in the crawl space.

LOCATION: The crawl space sump pump.

RECOMMENDATION: Repair or replace the discharge line. Hire a licensed plumber as needed.

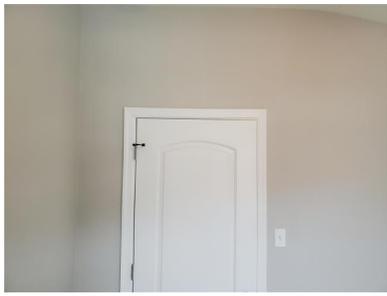
**7.6 Item 1 (Picture)**  
Door Binding (Second Floor/  
Center Front Bedroom)

LOCATION: One or more locations (see photos).

RECOMMENDATION: Repair (adjust or trim) or replace the door or doors as needed.

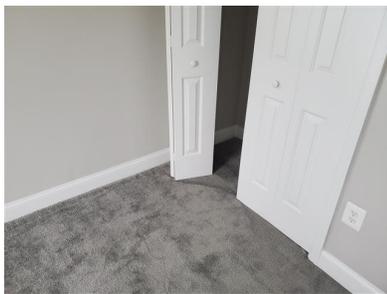
**7.6 Item 5 (Picture)**  
Door Rubs Carpet (Second Floor  
Left Front Bedroom Closet)

(2) A door rubs on the carpet. This affects proper function. It can also cause damage to the carpet over time.

LOCATION: The front left bedroom closet.

RECOMMENDATION: Adjust or trim the door as needed.

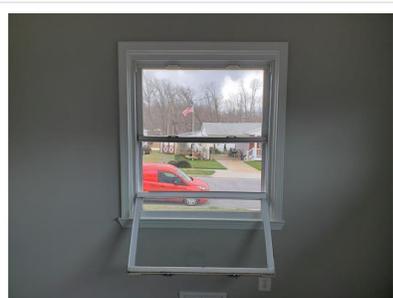
**7.7 Item 1 (Picture)**

LOCATION: The second floor front windows (older).

Windows Older/ Difficult to Open (Second Floor Front Windows)

RECOMMENDATION: Clean and service windows as needed. Use of a white Lithium grease can assist with smooth operation. If you find the windows do not operate after servicing, hire a window contractor to repair or replace the windows as needed.

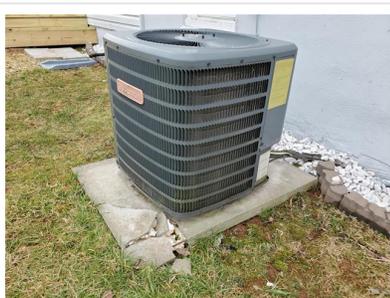
**9.1 Item 2 (Picture)**

LOCATION: The central AC condenser (rear exterior).

Central AC Condenser Pad Cracked (Rear Exterior)

RECOMMENDATION: Replace the pad. Hire a license HVAC contractor as needed.

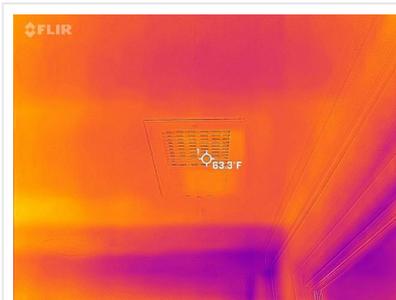
**9.1 Item 3 (Picture)**  
Cooling System Supply Temperature (63°F)

LOCATION: The cooling system.

RECOMMENDATION: Hire a licensed HVAC contractor for an evaluation of the cooling system and to provide repairs as needed.

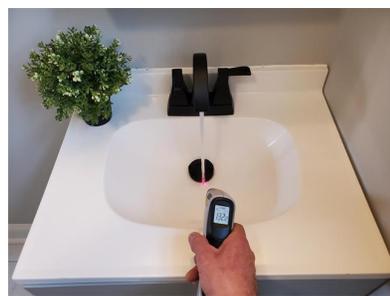
10.7 Item 1 (Picture)  
Water Temperature (A Little High)

- ❌ The water temperature as measured at fixtures is excessively high. Water hotter than 120°F can cause personal injury, particularly to children. This is a safety concern.  
LOCATION: The faucets and/or plumbing fixtures throughout the home.

RECOMMENDATION: Turn the water temperature down at the water heater thermostat.

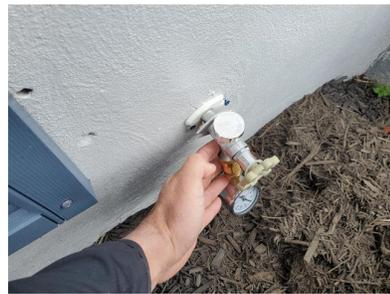
**10.8 Item 1 (Picture)**  
Hose Faucet Not Properly Secured (Front)

LOCATION: The front hose faucet.

RECOMMENDATION: Secure the faucet to the structure. Seal any openings with duct seal compound. Hire a licensed plumber as needed.

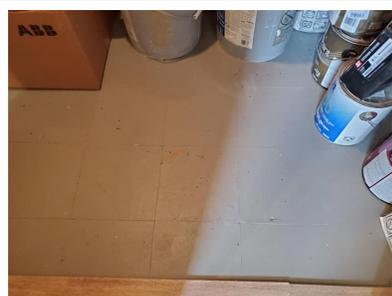
### 12.8 Item 1 (Picture)

LOCATION: The basement utility closet.

Floor Tiles Present That May Contain Asbestos/ Leave in Place (Basement Utility Closet)

RECOMMENDATION: Leave the floor tiles in place. Sanding, sawing, drilling, or removing the floor tiles can release asbestos fibers into the air. Proper removal and disposal procedures should be followed when removing asbestos floor tiles. Hire a licensed contractor if you plan on removing the floor tiles.

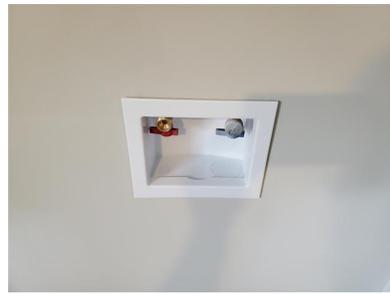
**13.6 Item 1 (Picture)**  
Standpipe Not Observed  
(Clothes Washer Connections  
Box)

LOCATION: The basement laundry area.

RECOMMENDATION: Request information from the current owner. If a stand-pipe is present, remove the knock-out at the clothes washer connections box. If a standpipe is not present, hire a plumber to install a proper drain for the clothes washer.

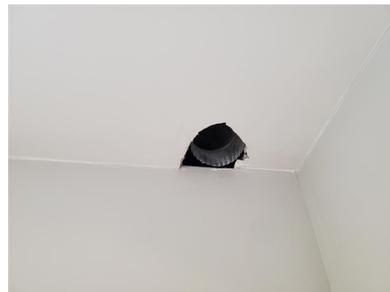
**13.7 Item 1 (Picture)**  
Clothes Dryer Vent Does Not  
Extend Below Ceiling (Basement  
Laundry Area)

LOCATION: The basement laundry area.

RECOMMENDATION: Hire a licensed contractor to extend the vent below the ceiling as needed.
