# STAVLAS HOME INSPECTIONS

## Inspection Report

1205 Cobb Rd  
Pikesville MD 21208

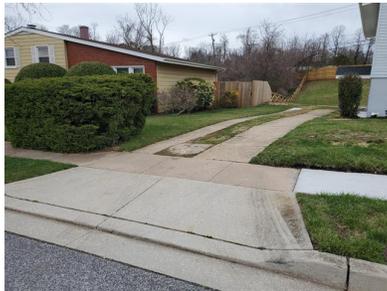
Driveway (Concrete/ See Comments)

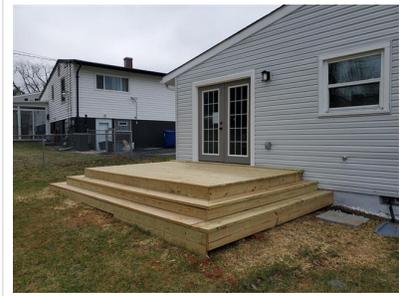
Rear Deck (Wood/ See Comments)

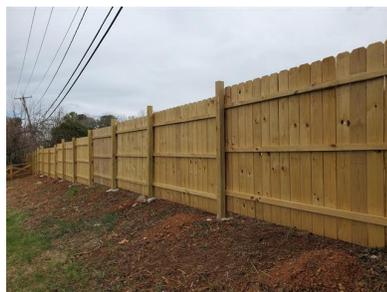
Rear Fence (Wood/ See Comments)

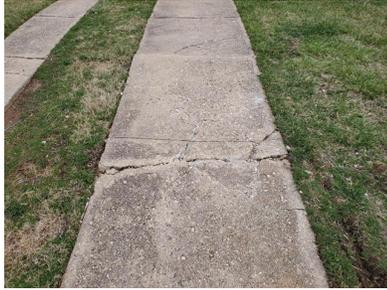
**2.0 Item 1 (Picture)**  
Driveway Deteriorated (Front Left)

(1) The driveway is deteriorated. If deterioration is not properly treated, the driveway will continue to degrade.

LOCATION: The driveway (front left).

RECOMMENDATION: Hire hey masonry contractor for an evaluation. Replacement of the deteriorated section or the driveway may be required.

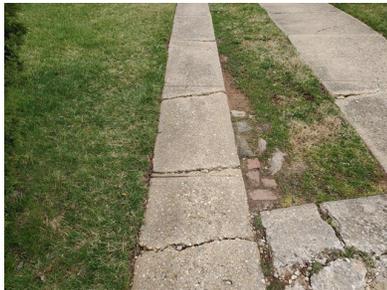
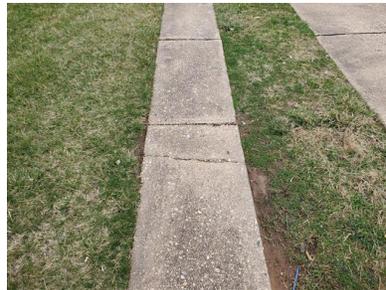
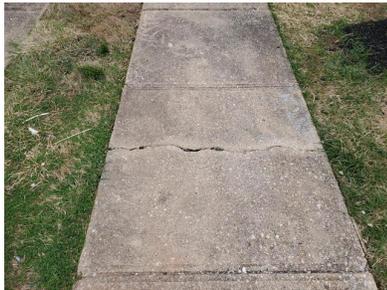
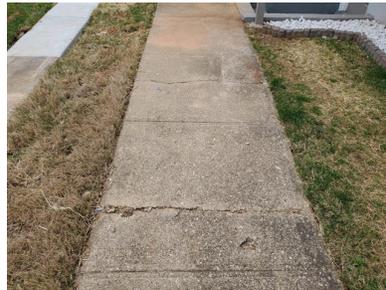
(2) The driveway is cracked. Cracks can permit moisture penetration and can result in cause further damage to the driveway.

LOCATION: The driveway (multiple locations).

**2.0 Item 2 (Picture)**  
Driveway Cracked (Multiple Locations)

**2.0 Item 3 (Picture)**  
Driveway Cracked (Multiple Locations)

**2.0 Item 5 (Picture)**  
Driveway Cracked (Multiple Locations)

**2.0 Item 6 (Picture)**  
Driveway Cracked (Multiple Locations)

RECOMMENDATION: Repair and seal the cracks. Use exterior grade textured caulk, concrete patching compound, or epoxy on concrete driveways. Hire a masonry contractor as needed.

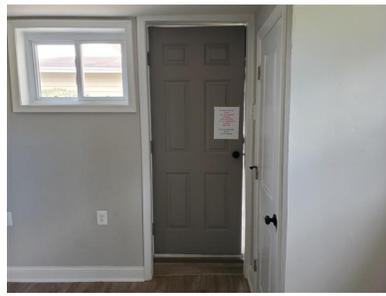
**2.6 Item 2 (Picture)**  
Door Binding Perspective Photo (Left Rear Basement Entrance Door)

RECOMMENDATION: Repair/ trim or replace the doors. Hire a general contractor as necessary.

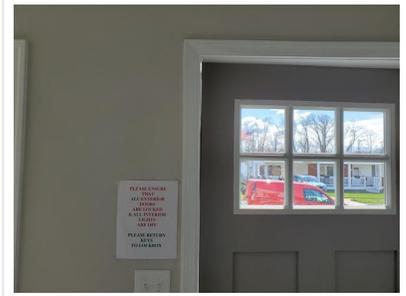
**2.6 Item 3 (Picture)**  
Door Binding (Front Entrance Door)

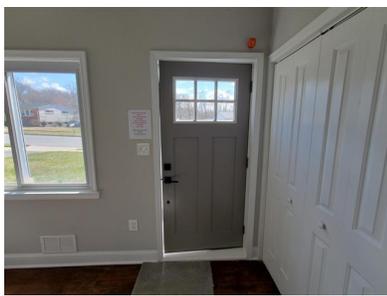
**2.6 Item 4 (Picture)**  
Door Binding Perspective Photo (Front Entrance Door)

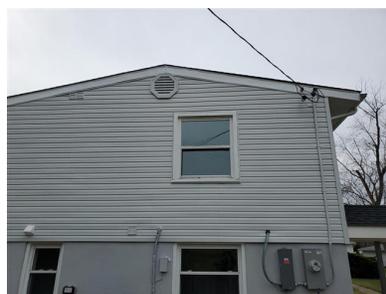
Window screens are missing or damaged. This affects proper function. Screens provide ventilation while excluding flying insects and other pests. Screens are often removed during winter months or for staging purposes.

**2.7 Item 2 (Picture)**  
Screen Missing/ Damaged (Rear Left/ Second Floor Window)

RECOMMENDATION: Replace any missing screens.

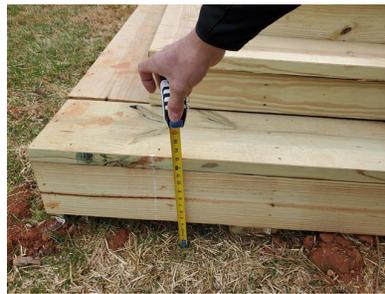
**2.8 Item 2 (Picture)**  
Lower Step Riser Height Excessive (Rear Deck)

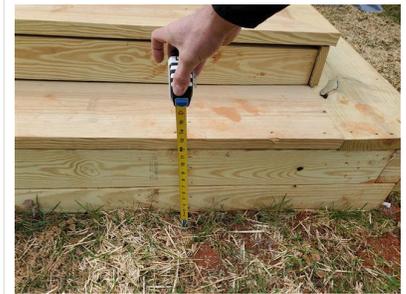
**2.8 Item 3 (Picture)**  
Lower Step Riser Height Excessive (Rear Deck)

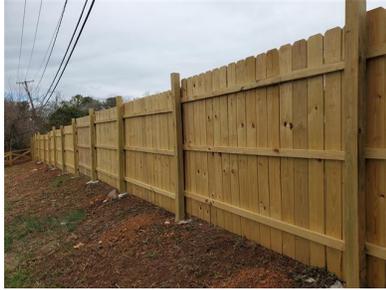
LOCATION: The rear fence and deck.

**2.12 Item 1 (Picture)**  
Fence Bare/ Not Painted or Stained (Rear)

RECOMMENDATION: Paint, stain, or seal the fence and deck.

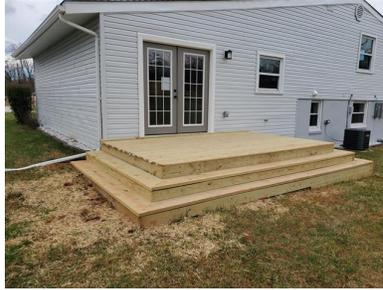
**2.12 Item 2 (Picture)**  
Deck Bare/ Not Painted or Stained (Rear)

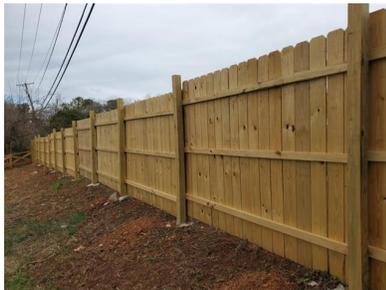
(2) Fence post caps are missing. This can allow water to penetrate the posts which can result in deterioration over time.

LOCATION: The rear fence.

**2.12 Item 3 (Picture)**  
Fence Post Caps Missing (Rear Fence)

RECOMMENDATION: Add post caps to prolong the life of the fence posts.

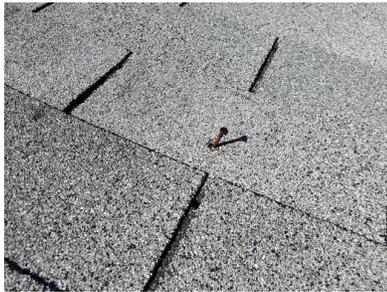
There is an partially driven and exposed nail head, and improperly sealed nail heads on the roof. Unsealed nail heads are prone to rusting and water intrusion.

LOCATION: The roof (left front, ridge vents, and flashing).

**3.0 Item 1 (Picture)**  
Partially driven/ Improperly Sealed Nail (Left Front Roof)

RECOMMENDATION: Remove or replace the partially driven nail head and seal exposed nail heads with an approved roofing sealant/product. Hire a qualified roofing contractor as needed.

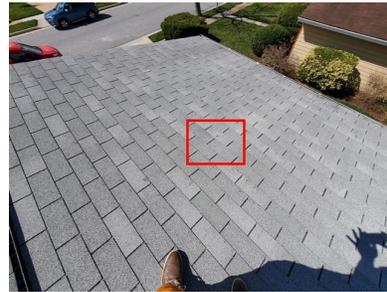
**3.0 Item 2 (Picture)**  
Partially Driven/ Improperly Sealed Nail (Left Front Roof)

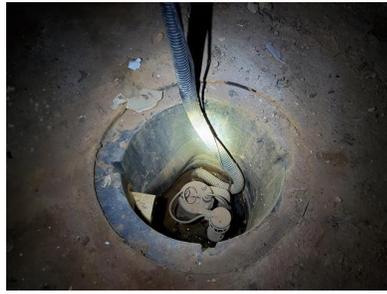
Crawl Space Sump Pump (Submersible/ See Comments)

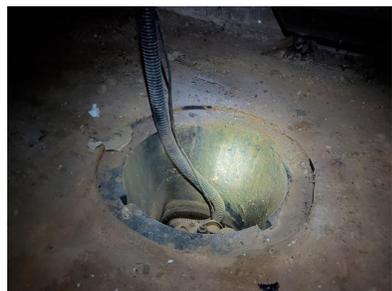
**5.4 Item 7 (Picture)**  
Cover Not Installed (Crawl Space Sump Pump)

(5) The sump pump cover is not installed. This is a safety concern (trip/fall hazard). It can also allow debris to enter the sump pit and risk clogging or damaging the pump.

LOCATION: The crawl space sump pump.

RECOMMANDATION: Install the sump pump cover.

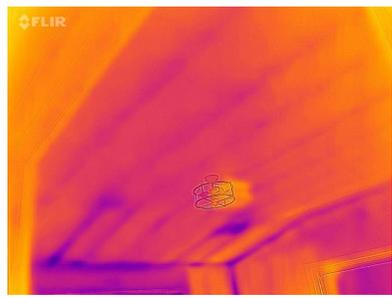
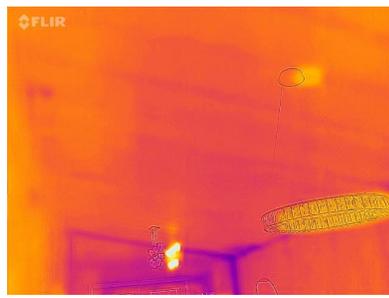
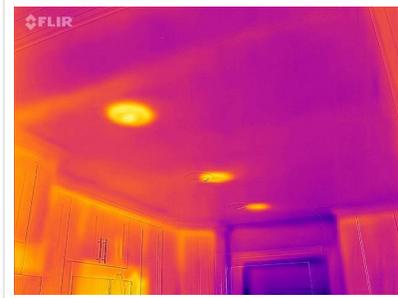
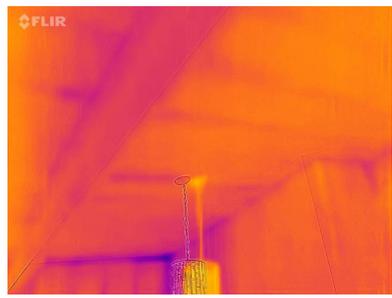
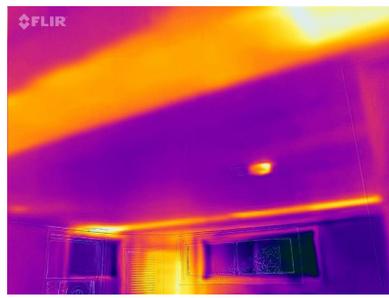
Thermal IR Scan (No Evidence of  
Water Intrusion Through Roof)

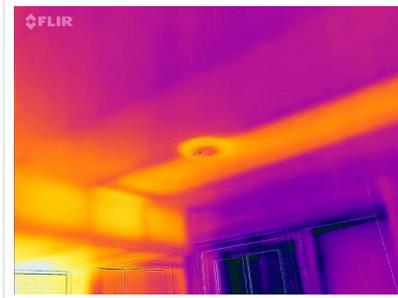
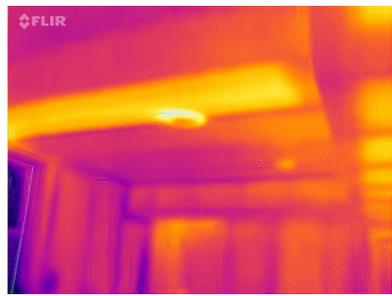
Thermal IR Scan (No Evidence of Plumbing Leaks Between Floors)

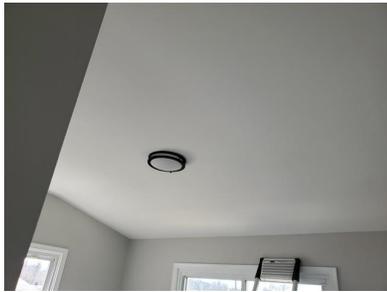
An anomaly was observed while performing a thermal IR scan of the home in the ceiling under the partially driven nail in the roof (see comments under Roofing). Testing with a moisture meter indicated high moisture content (wet) at the time of inspection. There may be hidden damage. Water intrusion, even if only under certain conditions, can result in conditions conducive to mold growth.

LOCATION: The left front bedroom.

**7.2 Item 1 (Picture)**  
Visible Light/ No Evidence of Water Intrusion (Front Left Bedroom)

RECOMMENDATION: Hire a contractor for an evaluation and to provide repairs as needed. The source of water intrusion should be mitigated.

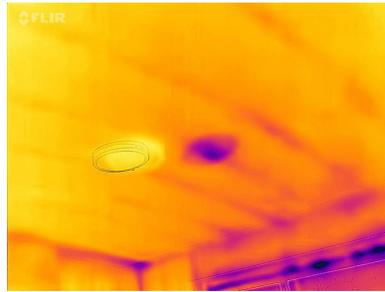
**7.2 Item 2 (Picture)**  
Thermal IR Scan/ Anomaly Observed (Front Left Bedroom)

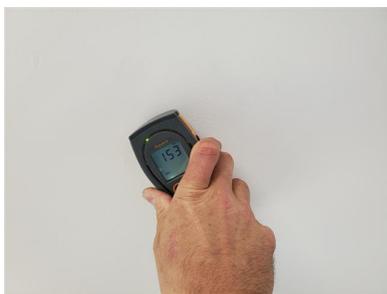
**7.2 Item 4 (Picture)**  
Moisture Meter Control Reading (Front Left Bedroom)

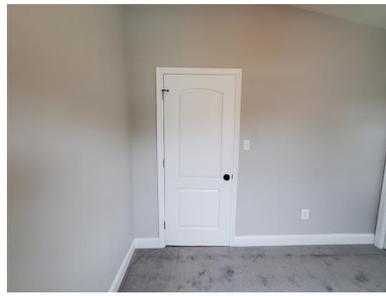
**7.6 Item 2 (Picture)**  
Door Binding Perspective Photo  
(Second Floor/ Center Front  
Bedroom)

RECOMMENDATION: Repair (adjust or trim) or replace the door or doors as needed.

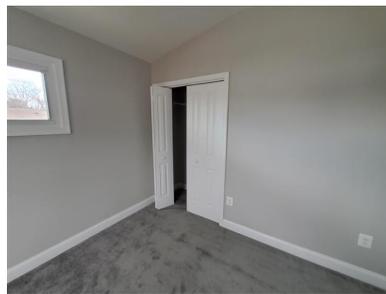
(2) A door rubs on the carpet. This affects proper function. It can also cause damage to the carpet over time.

**7.6 Item 6 (Picture)**  
Door Rubs Carpet Perspective  
Photo (Second Floor Left Front  
Bedroom Closet)

RECOMMENDATION: Adjust or trim the door as needed.

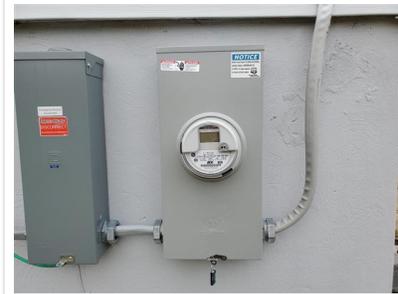
Electrical Service Meter (BGE/ 200 Amp/ Properly Secured)

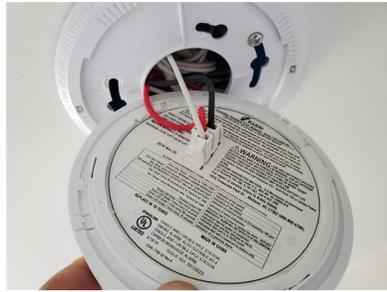
Hallway Combination Smoke and Carbon Monoxide Detectors (Hard-Wired/ Interconnected/ MFR Date 2016)

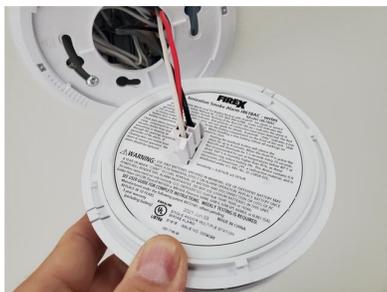
Bedroom Smoke Detectors (Hard-Wired/ Interconnected/ MFR Date 2021)

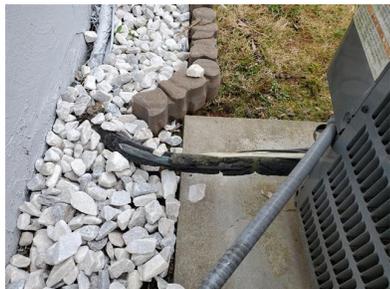
**9.1 Item 1 (Picture)**

(1) The insulation on the refrigerant suction line is damaged. This can affect system efficiency.

LOCATION: The central AC condenser (rear exterior).

Insulation Damaged/ Refrigerant Suction Line (Central AC Condenser/ Rear)

RECOMMENDATION: Replace the insulation with exterior grade insulation. Hire an HVAC contractor as needed.

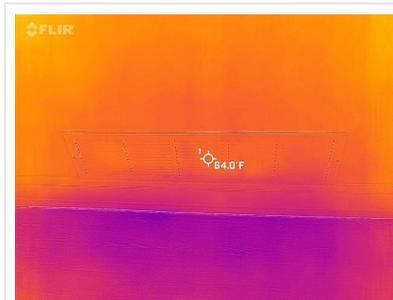
**9.1 Item 4 (Picture)**  
Cooling System Return Temperature (64°F)

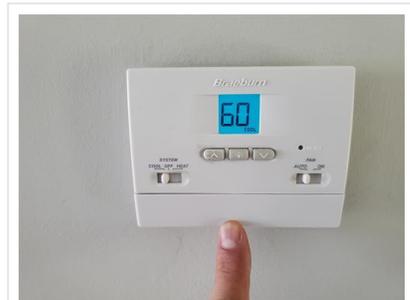
**9.1 Item 5 (Picture)**  
Thermostat (Set to Cool)

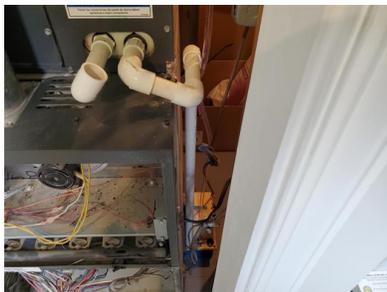
**9.3 Item 1 (Picture)**

LOCATION: The primary condensate drain line (central AC evaporator coil/ basement utility closet).

Clean-Out Port Missing (Primary Condensate Line/ Evaporator Coil/ Basement Utility Closet)

RECOMMENDATION: Hire an HVAC contractor to install a clean out port as needed.

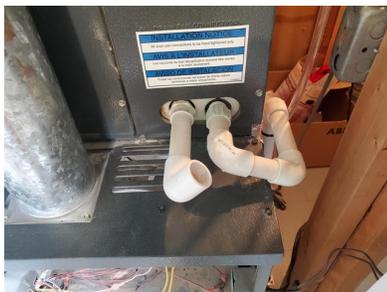
**9.3 Item 2 (Picture)**

(2) The secondary condensate drain line is open. A Safe-T-Switch is missing. The secondary drain line can leak in the event of a clog in the primary drain line. This can result in water damage to surrounding areas.

LOCATION: The secondary drain line (central AC evaporator coil/ basement utility closet).

Secondary Drain Line Open/ Safe-T-Switch Not Present (Secondary Drain Line/ Evaporator Coil/ Basement Utility Closet)

RECOMMENDATION: Hire a licensed HVAC contractor add a Safe-T-Switch or extend the secondary drain line to the condensate pump. .

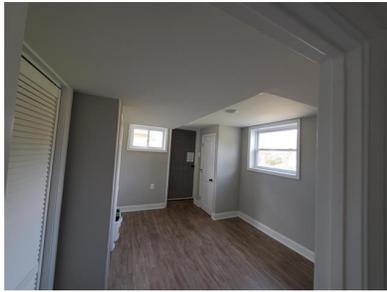
(1) Supply registers are missing (no heat source in a habitable room). Each habitable room should have a heat source. This can effect the comfort of the residence.

LOCATION: The basement laundry area.

**9.4 Item 1 (Picture)**  
Supply Registers Missing  
(Basement Laundry Room)

RECOMMENDATION: Hire a licensed HVAC contractor for an evaluation to add supply and return registers as needed.

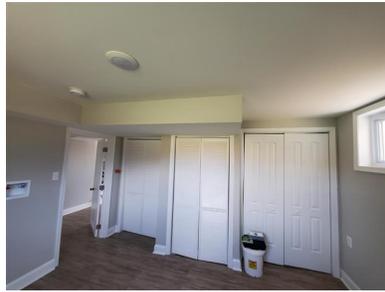
**9.4 Item 2 (Picture)**  
Supply Registers Missing  
(Basement Laundry Room)

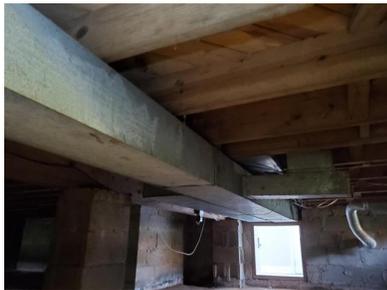
(2) The ductwork insulation is missing. This can reduces system efficiency and cause condensation issues in the crawl space.

LOCATION: The crawl space.

**9.4 Item 3 (Picture)**  
Insulation Missing (HVAC  
Ductwork/ Crawl Space)

RECOMMENDATION: Hire an HVAC contractor to properly install insulation.

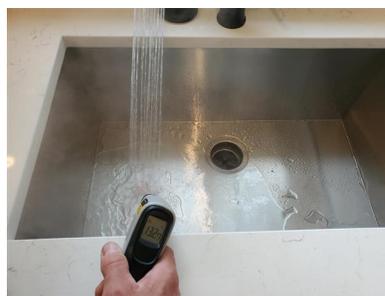
- ❌ The water temperature as measured at fixtures is excessively high. Water hotter than 120°F can cause personal injury, particularly to children. This is a safety concern.  
LOCATION: The faucets and/or plumbing fixtures throughout the home.

10.7 Item 2 (Picture)  
Water Temperature (A Little High)

RECOMMENDATION: Turn the water temperature down at the water heater thermostat.

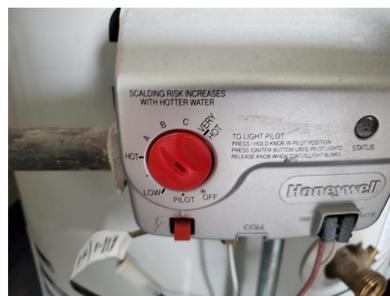
10.7 Item 3 (Picture)  
Thermostat Set High (Water Heater)

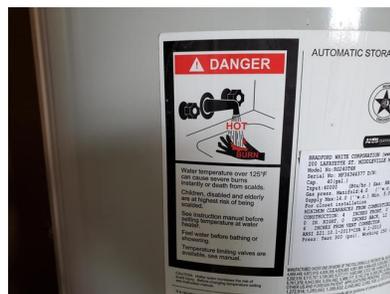
10.7 Item 4 (Picture)  
High Water Temperature Warning (Water Heater)

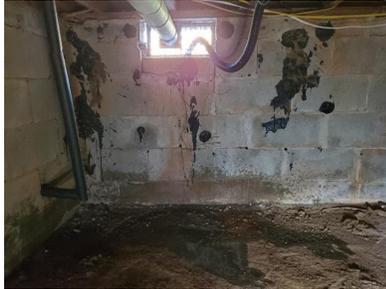
INFORMATION: There is visible evidence of a previous treatment for termites. Drill holes were observed. Many times, treatment is performed as a preventative measure. Request any available documentation from the current owner. Continue treatment as needed.

**12.5 Item 1 (Picture)**  
 Drill Holes/ Previous Termite Treatment (Crawl Space Concrete Blocks)

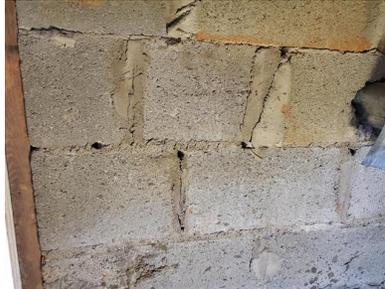
**12.5 Item 2 (Picture)**  
 Drill Holes/ Previous Termite Treatment (Crawl Space Concrete Blocks)

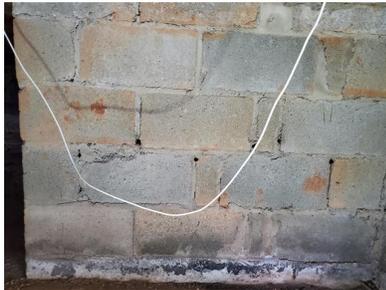
**12.5 Item 3 (Picture)**  
 Drill Holes/ Previous Termite Treatment (Crawl Space Concrete Blocks)

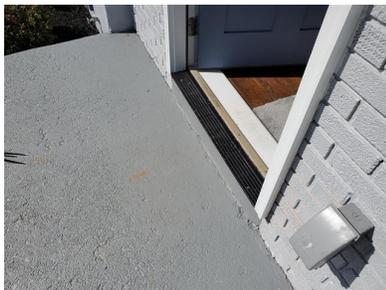
**12.5 Item 4 (Picture)**  
 Patched Drill Holes/ Previous Termite Treatment (Front Stoop)

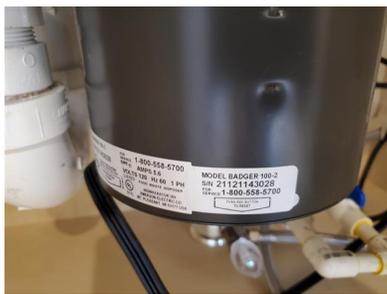
Garbage Disposal Data Tag (MFR Date 2021)

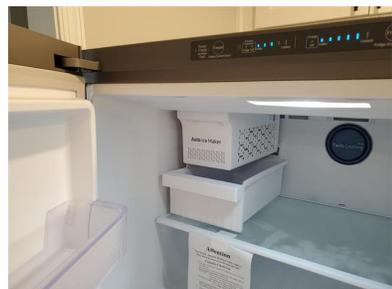
13.0 Item 1 (Picture)

LOCATION: The refrigerator (kitchen).

RECOMMENDATION: Install the water line and confirm operation. Hire an appliance technician as needed.
